# Thyratron Related Problems in the Linac Modulator

- Possible reasons why the Linac Modulator does not pulse
- Possible reasons why some of the pulses are missing
- Possible reasons why excessive pulses are produced

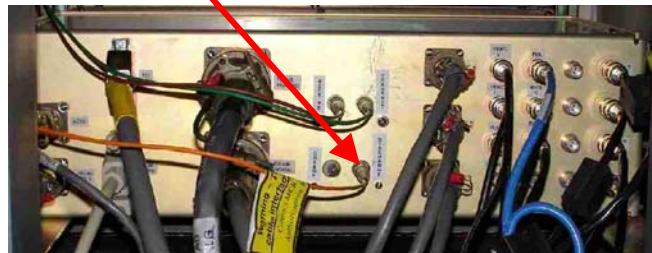
Interface Chassis  
Rear View

1. Discharge command fiber-optic cable is damaged, NOT connected, or there is no light pulse.

Human eye is not able to detect light pulse in this cable.

If you have reason to suspect pulse absence, make sure that the modulator is in at least “Ready-to-Pulse” state, then contact Nick DiMonte.

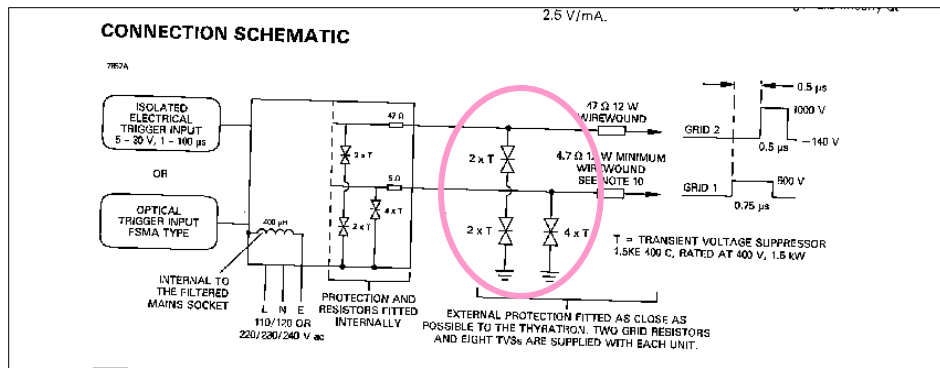
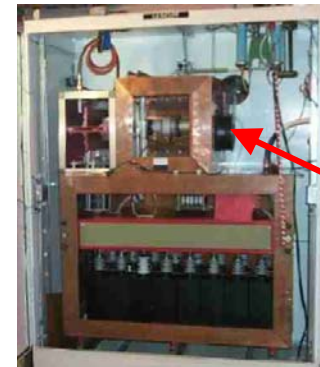
## 5. The Transient Voltage Suppressors Failed

Usually, the Suppressors or Transorbs fail to short state. It happens more often in the modulators where older thyratrons are in use.

The transorbs are located behind the side panel of the Thyatron box

The only way to fix the modulator is to replace failed transorbs

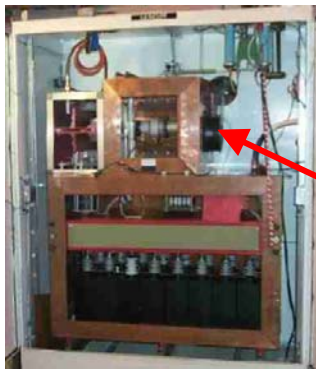
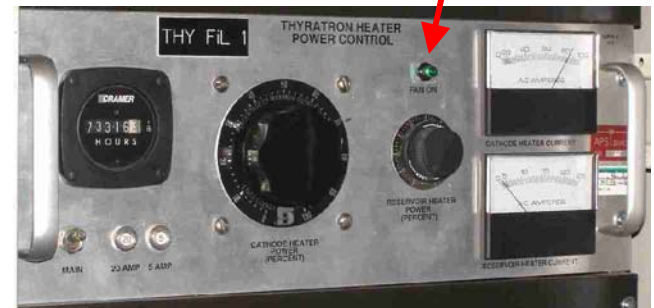
## 6. Thyatron cooling fan Failed

The fan is equipped with an air flow sensor. If flow is insufficient, thyatron filament power supply will be turned off, and the modulator will trip

The fan and sensor are located on the side panel of the Thyatron box

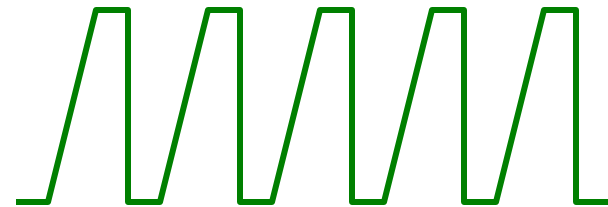
Normal pulsing.

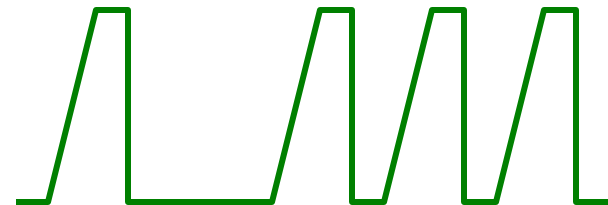
## 9.b Some pulses are missing.

- Low filament voltage (must be 6.3V)
- Tube's "End-of-Life" is approaching; you can try to increase filament voltage a little. It may eliminate the problem for some while.

Some pulses are missing.

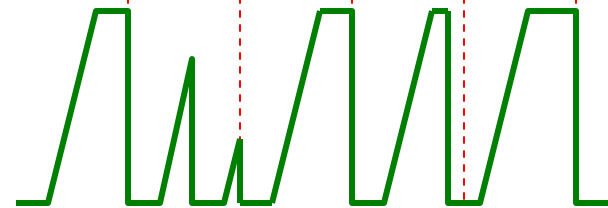
9.b The thyatron produces excessive pulses (or the tube pulses by its own).

Excessive pulsing.

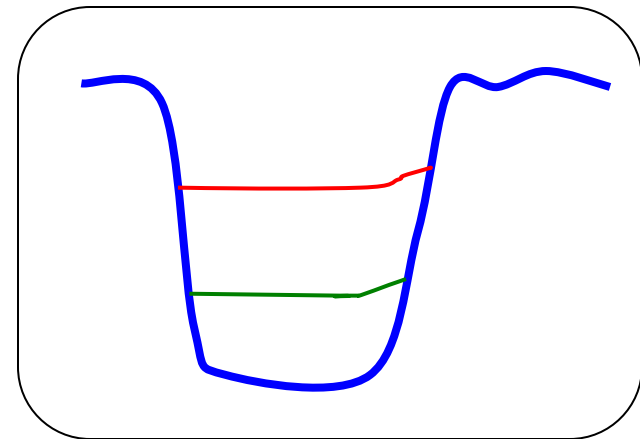
- Too high filament voltage (must be 6.3V);
- Tube's internal problems: the Deuterium reservoir is overheated. Nothing can be done because the reservoir filament is combined with the cathode one.
- The tube is defective. Such a tube was found recently in one of the modulators: it did not hold high voltage.

Another symptom of the same problem: several pulses have lower amplitude than the others
