# Thyratron Related Problems in the Linac Modulator

- Possible reasons why the Linac Modulator does not pulse
- Possible reasons why some of the pulses are missing
- Possible reasons why excessive pulses are produced

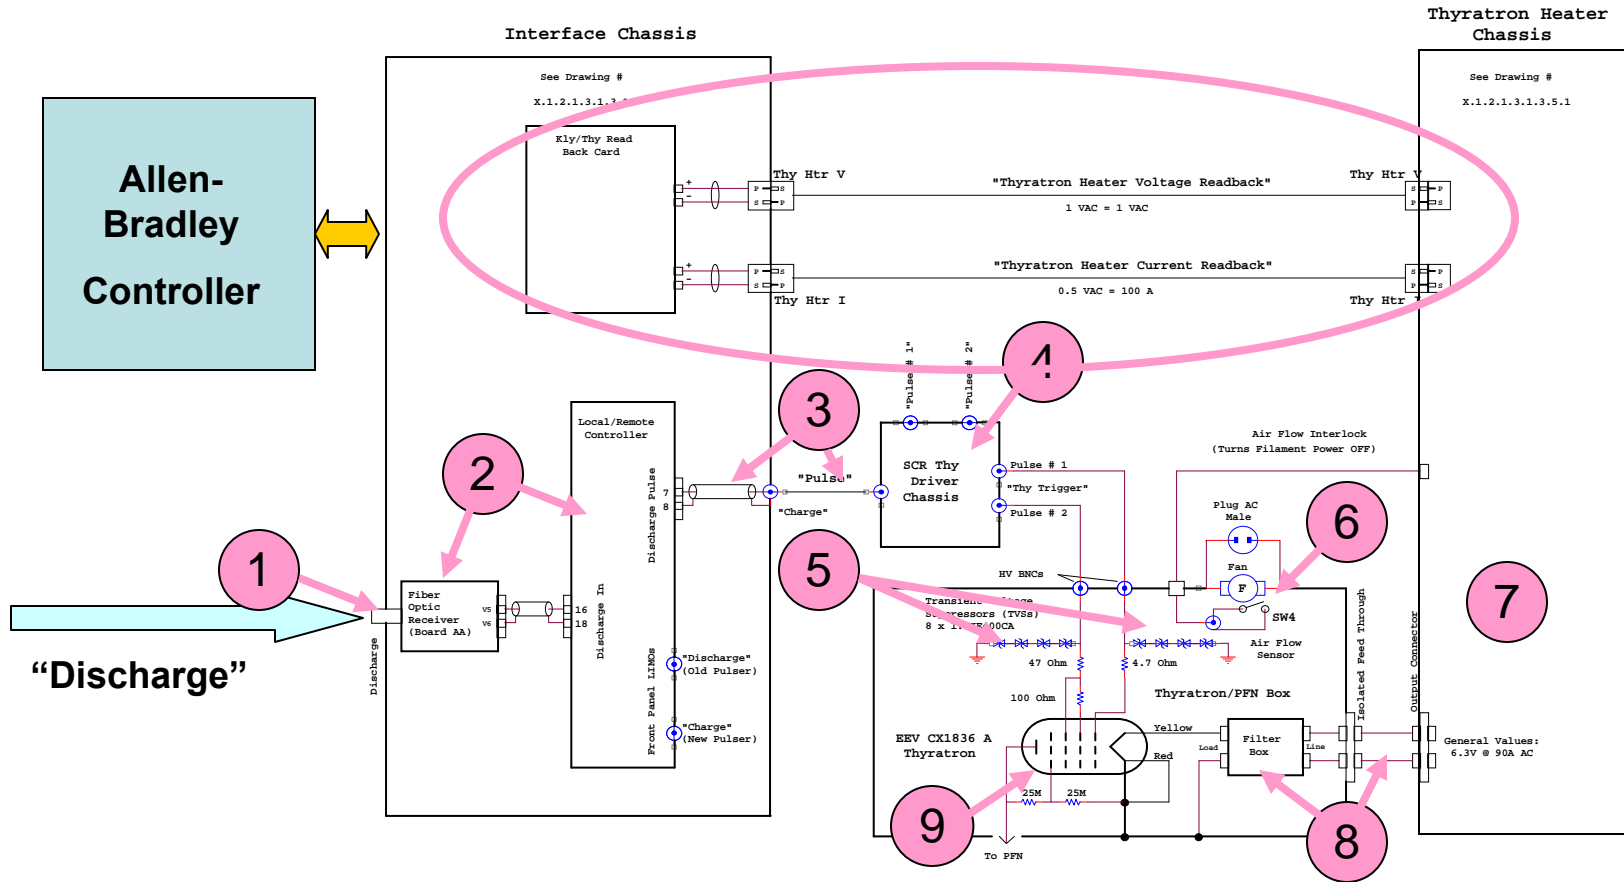
This is Filament voltage and current readback area. Any real problem here will cause modulator trip. If the readings look abnormal and the modulator is running, look into Allen-Bradley controller.

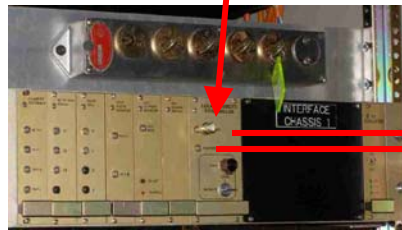
Interface Chassis  
Front View

## 2. Optical receiver or Local/Remote PCB of the Interface chassis failed

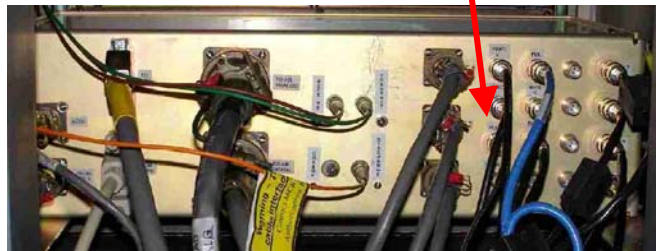
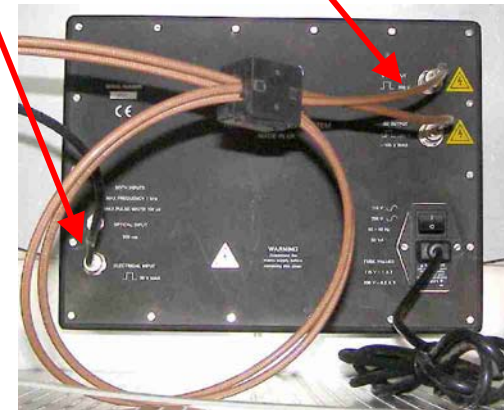
3. Driver's input or output cable is connected to a wrong BNC connector of the Interface chassis,

Any of the input/output cables is damaged or disconnected including thyatron ends located in the PFN cabinet

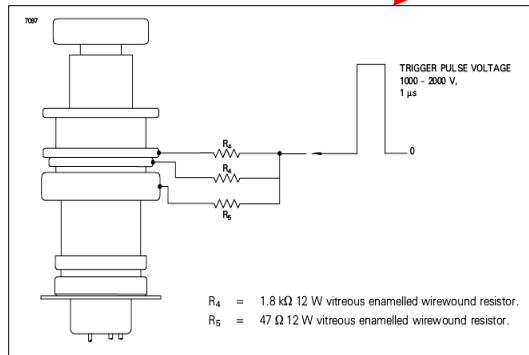
HV Pulse in the old-style Driver

## 4. The Driver is not functioning properly

Observing HV output pulses at the Driver's output connectors is possible using special HV probes, but it requires special measures to obey all safety rules.

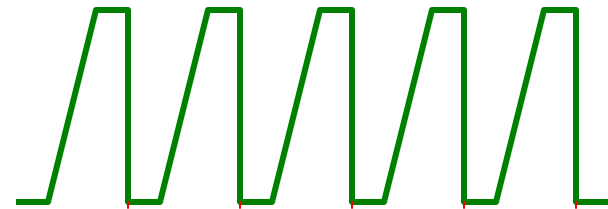
Normal pulsing.

9.b The thyatron produces excessive pulses (or the tube pulses by its own).

It may be found while observing PFN voltage with a scope or sometimes by listening to the sound from the oil tank.
